Project Profile

Port Pirie Iron Ore Transhipment Port Project

Client	Kerman Contracting Ltd
Location	Port Pirie, South Australia
Duration	August 2011 - September 2011
Contract	Port Pirie Iron Ore Facilities Remediation
Cost	\$1 Million

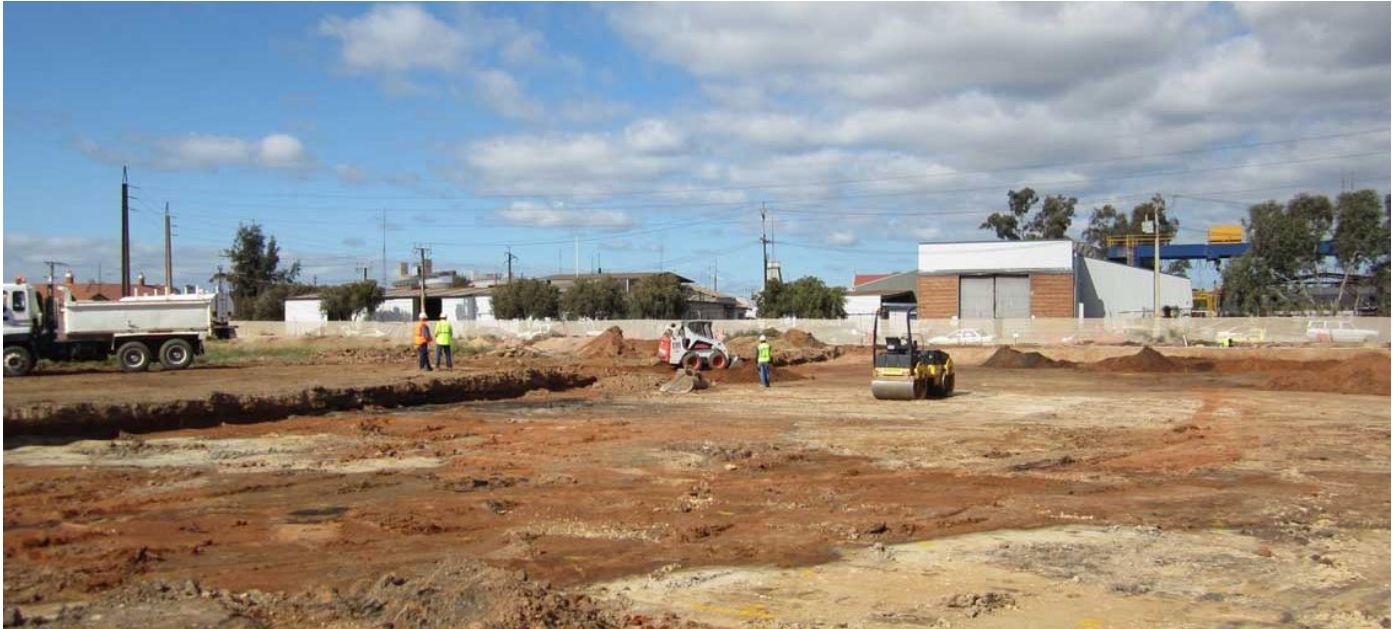
Containment of both leachable and non-leachable contaminated materials beneath the future building's footprint.
